# Ricardo L. Treviño Junior High School

## Facilities Update

December 5, 2023

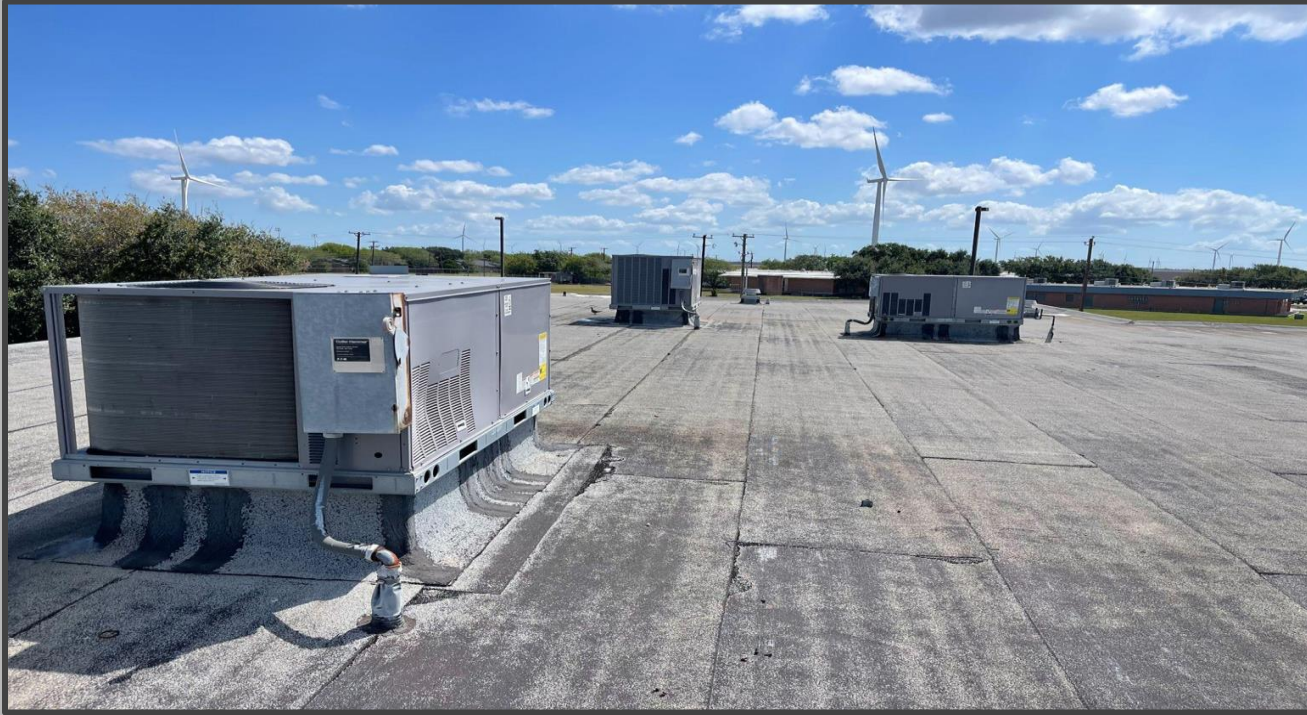
Rooftop Units will reach life expectancy in 2-3 years. Typical AC Units have a 10-15 year expectancy. Units have a domino effect for classroom and building cooling/heating.

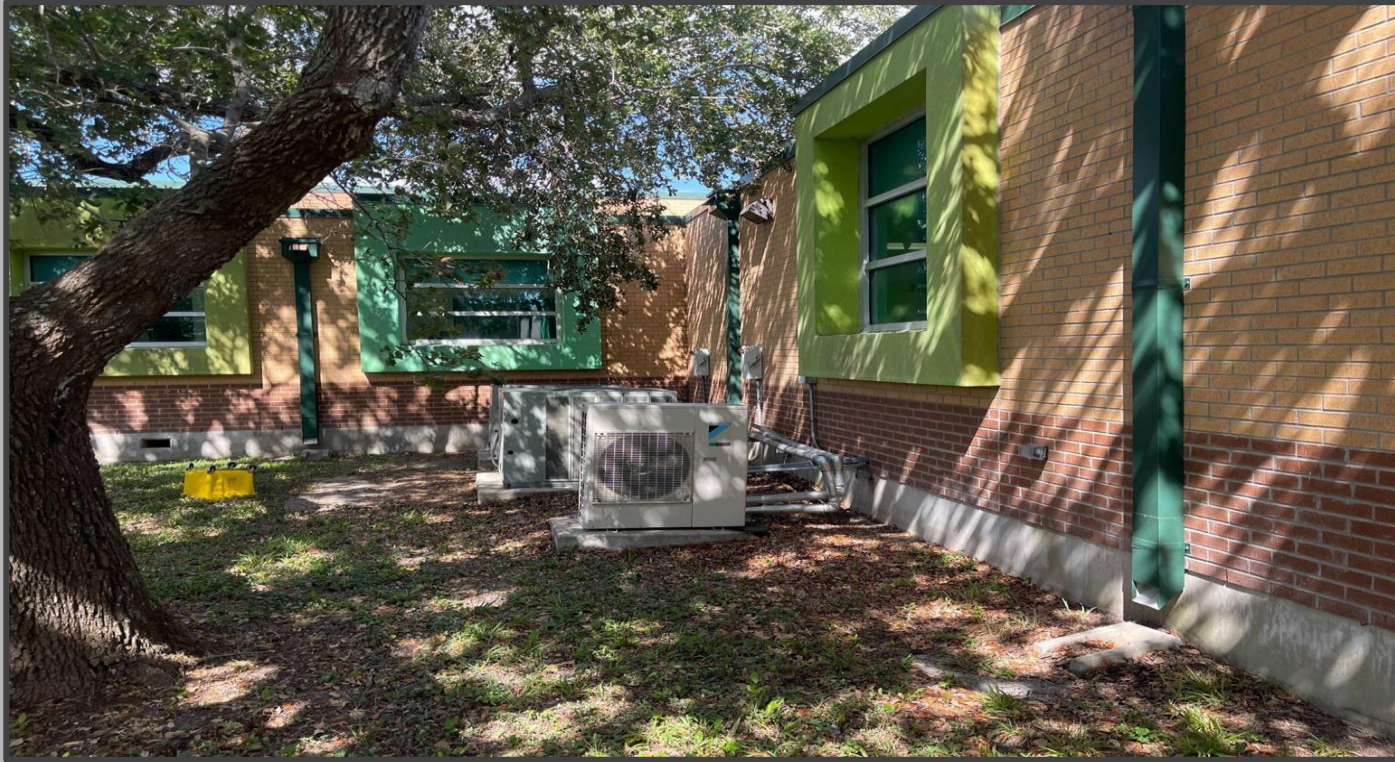
These units control Art Room, Band Hall and SRO Office.  
Daiken Units

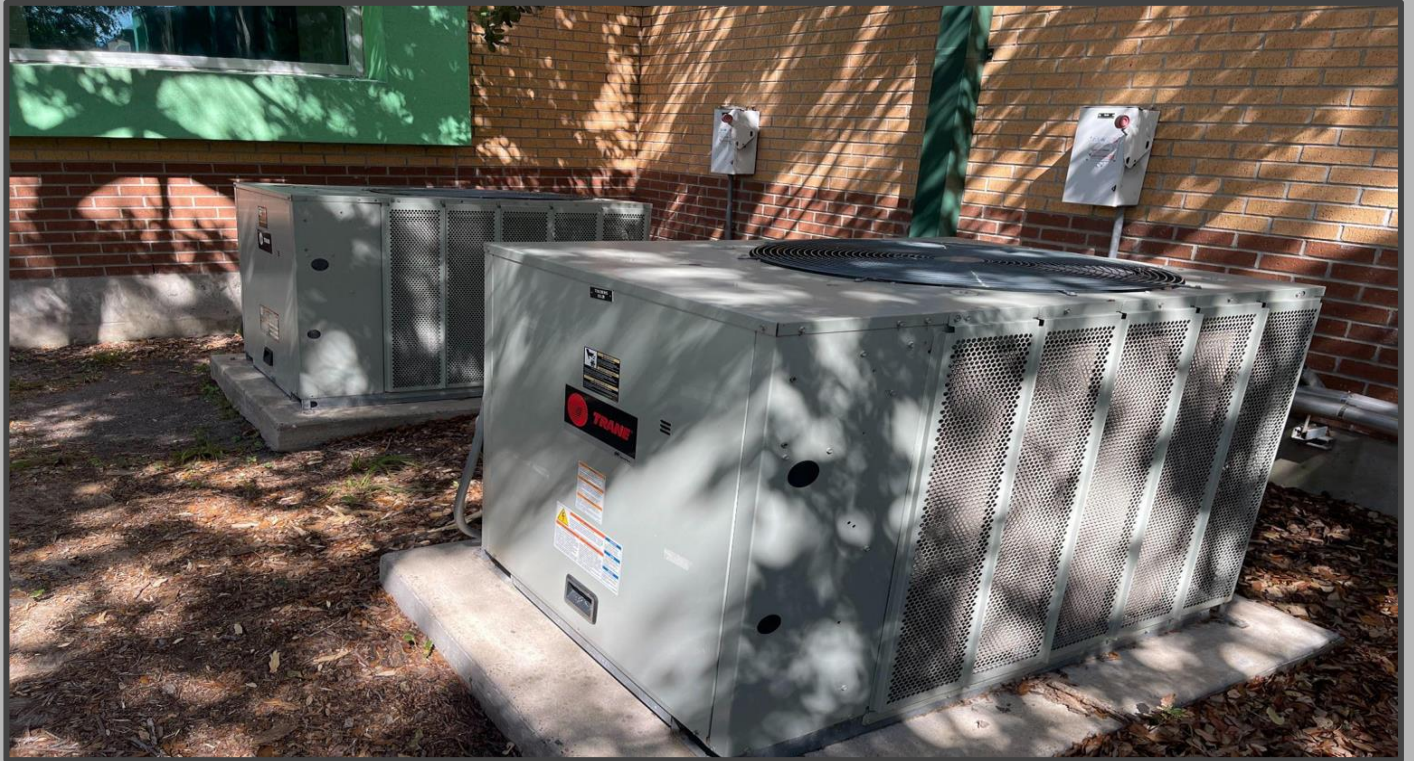
This particular AC Unit (TRANE) controls 3 classrooms and the SRO office. Life expectancy is also in the 2-3 year range of a typical 10-15 years.

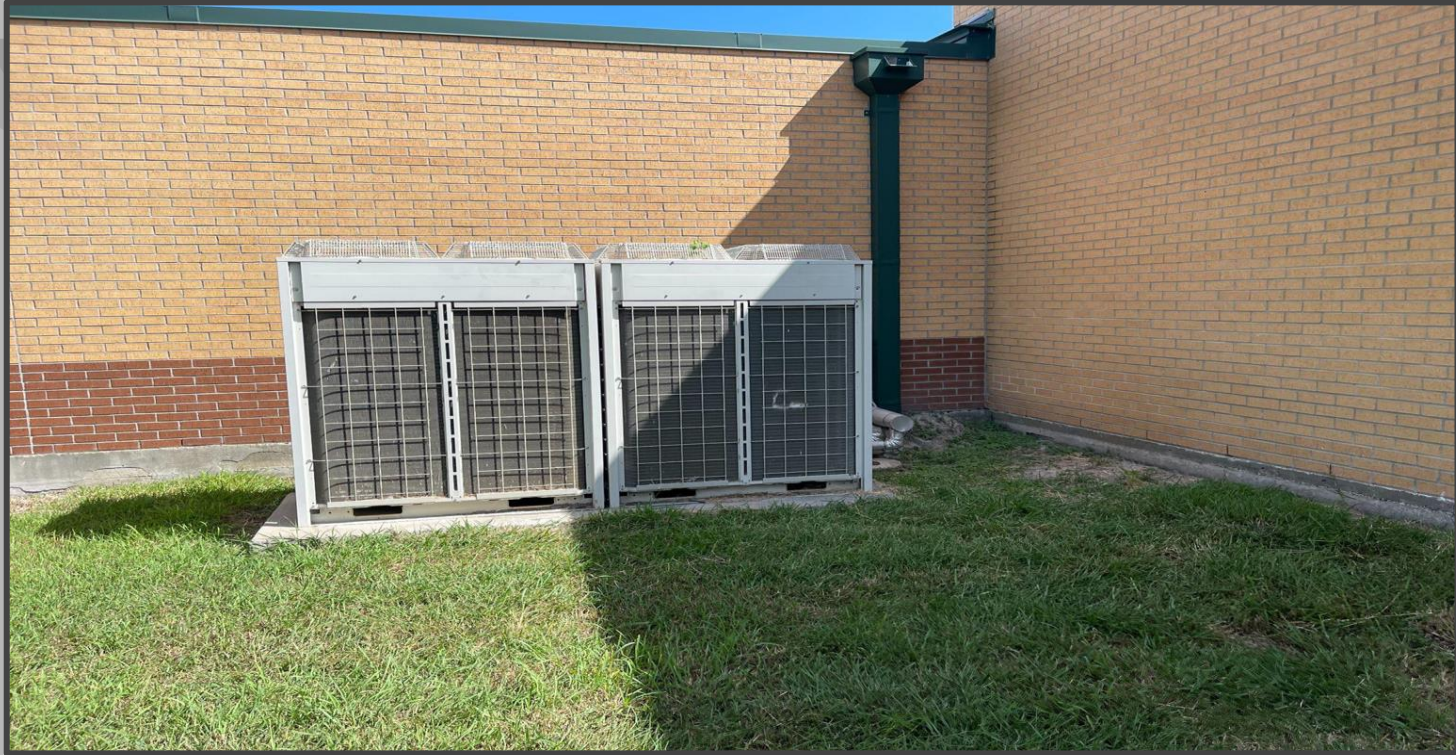
AC Units control majority of one wing. This has been an ongoing issue. At one point last school year, a wing had issues at least 6 months. Life expectancy left of the AC unit is in the range of 2-3 years.

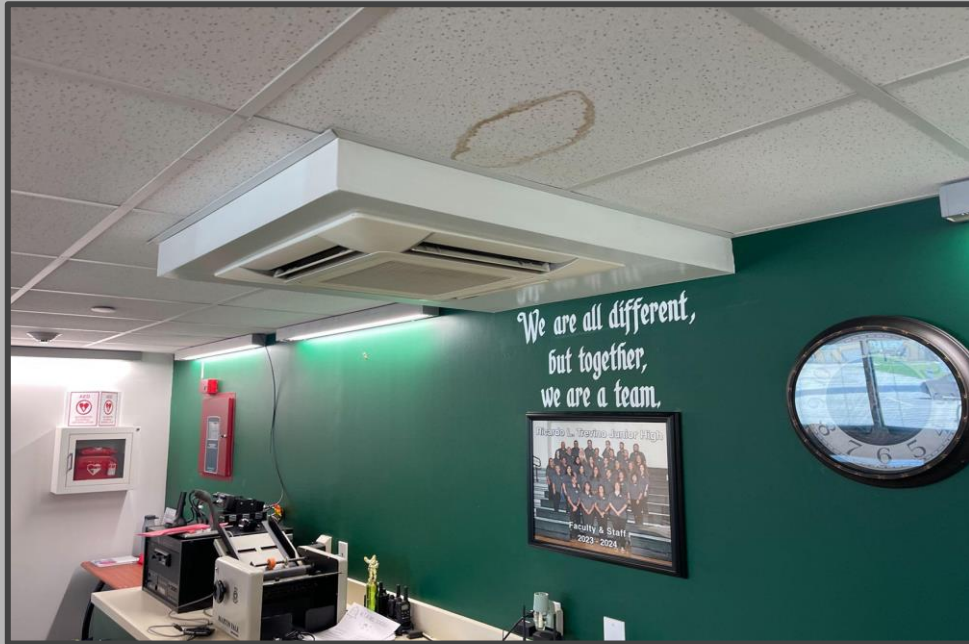
Front Office

Roofing issues have been a hindering factor on our campus. Various issues of leaking, AC condensation all have an effect on the “feel” of the building along with stained ceiling tiles.

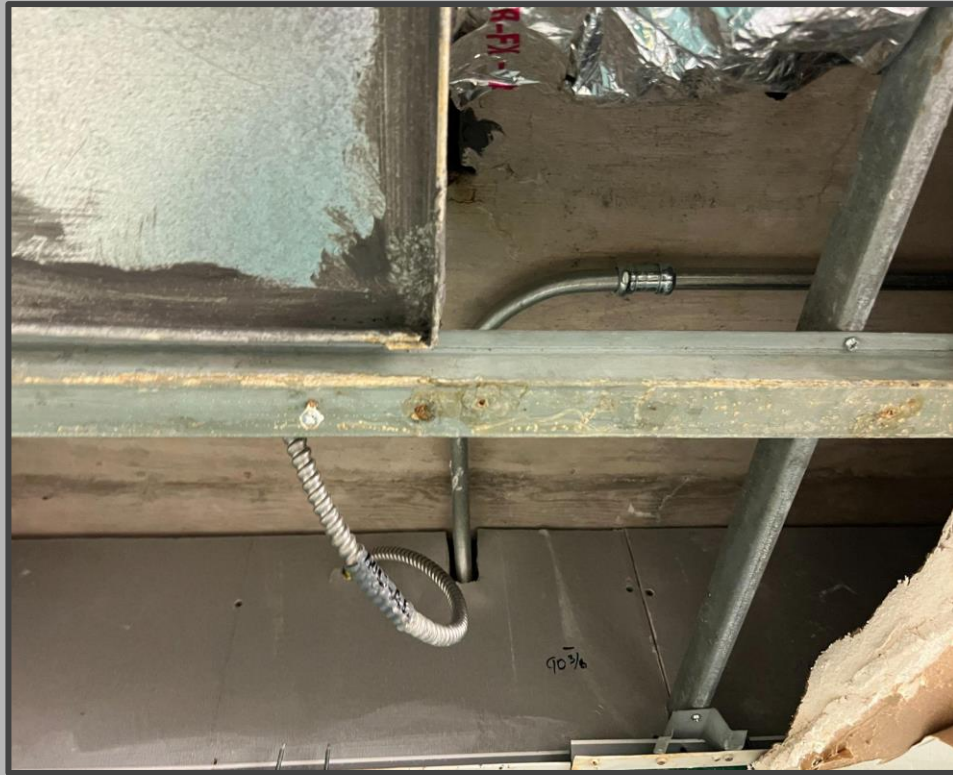
Exposed roofing/damaged ceiling tiles near staff lounge

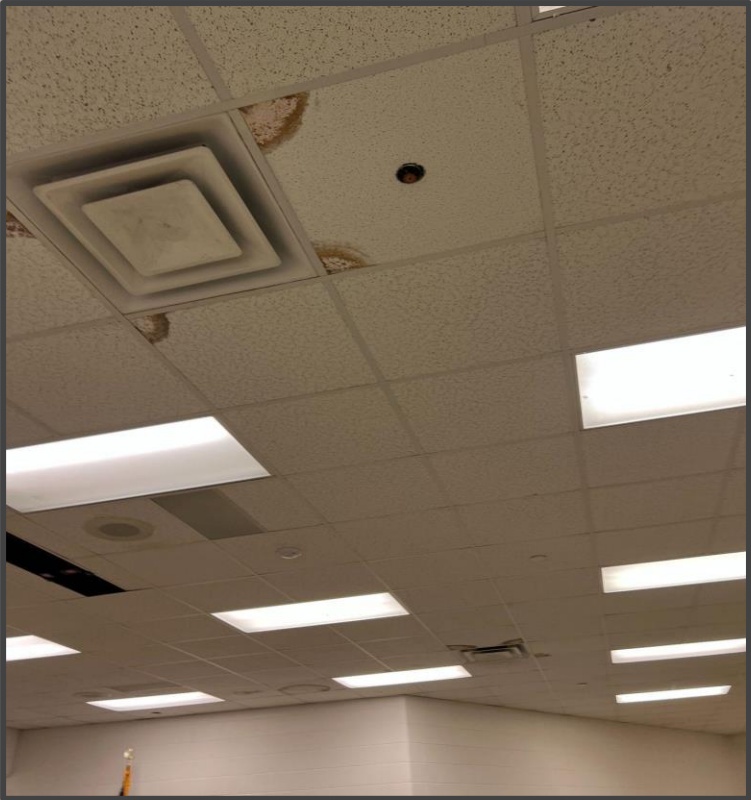
Library ceiling tiles

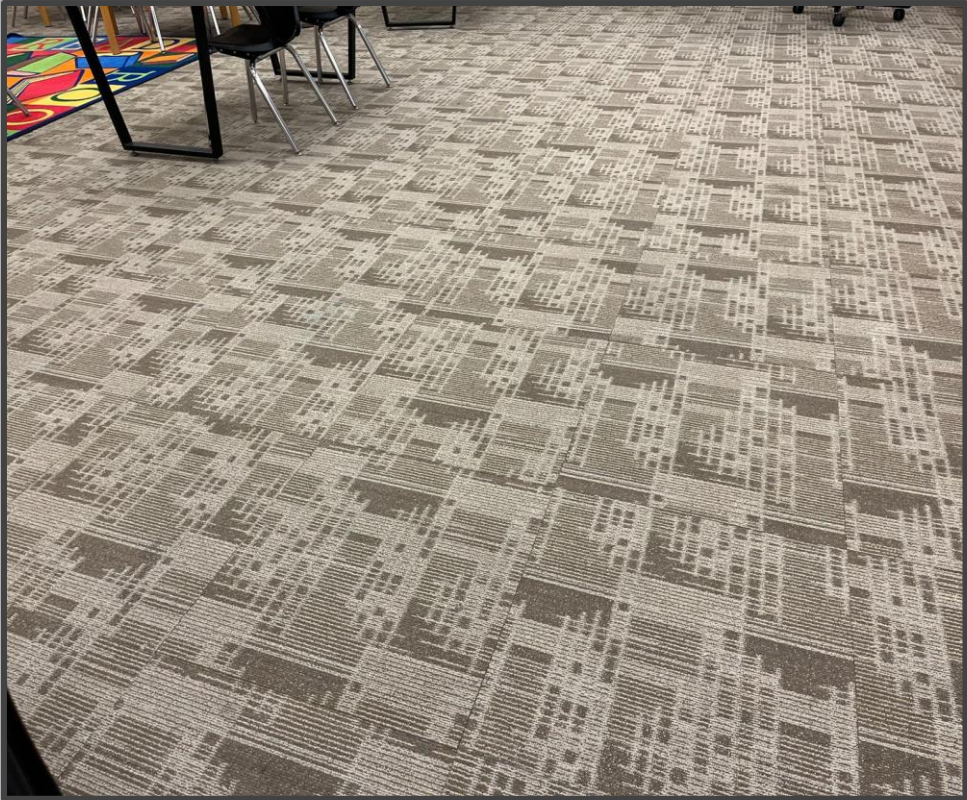
Library floor-musky/stained

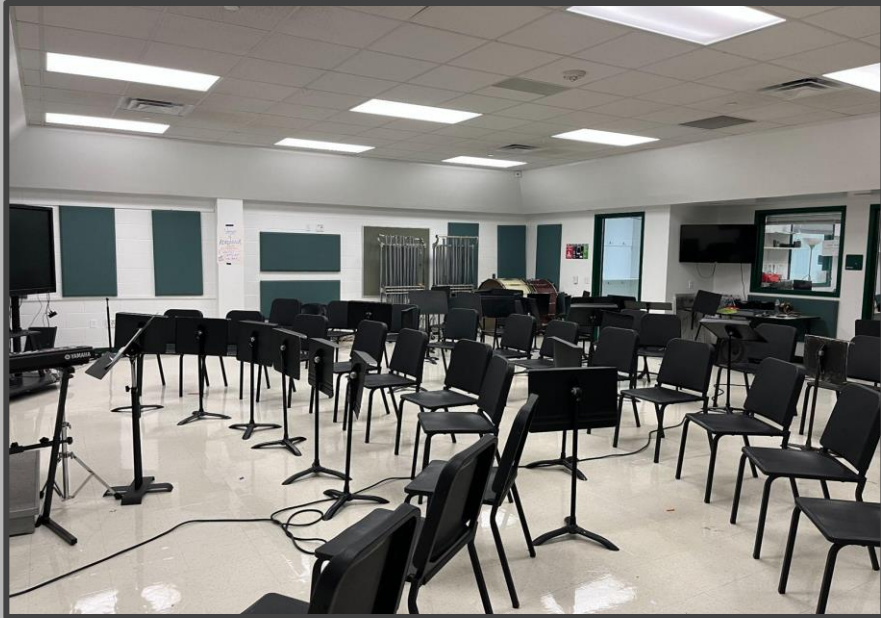
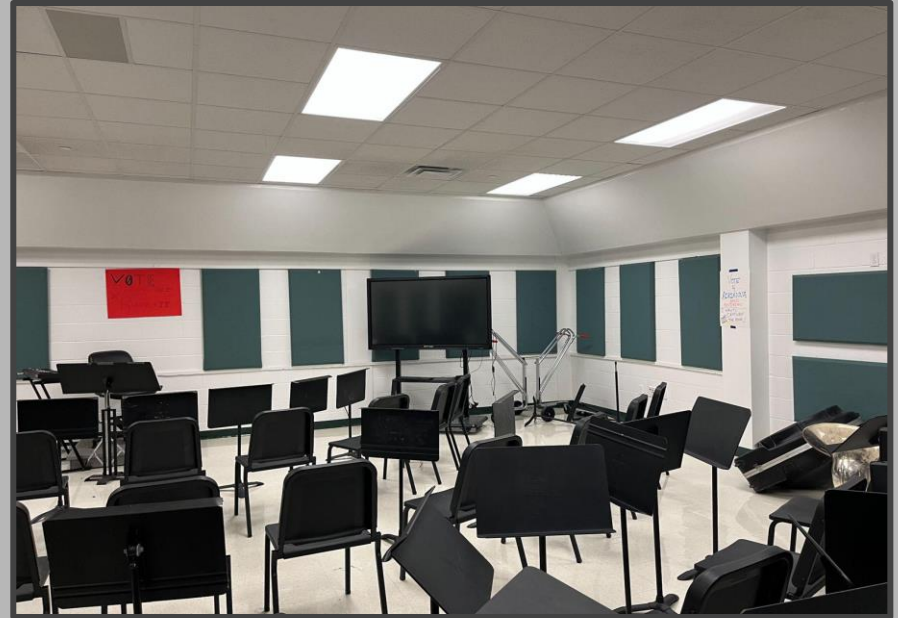
A successful band program starts at RLTH. With over 65 students in one class period, this creates a “full house.” Ceiling is low (built over existing established building), acoustics are not up to par, crowded area for practice. A full band creates safety and sound barriers and inadequacies for band director to conduct/redirect.

Decibel reading  
during band practice  
of Christmas Music.

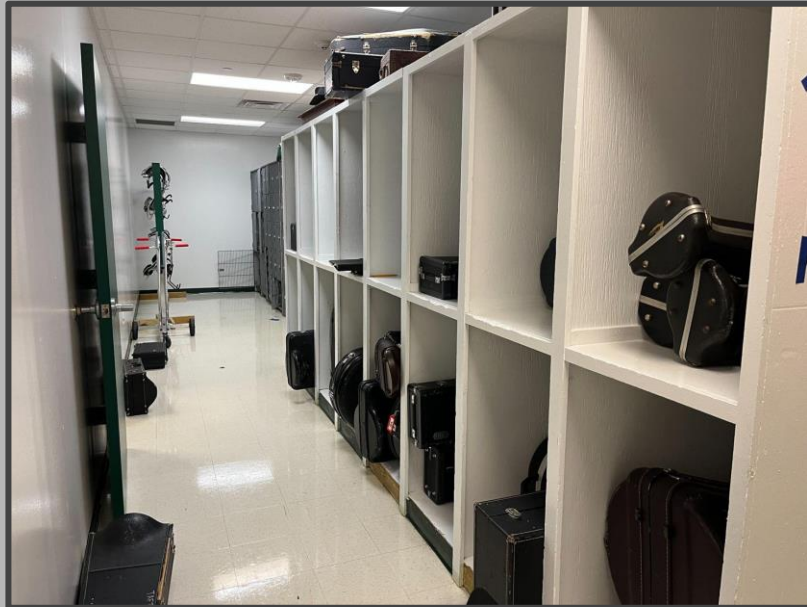
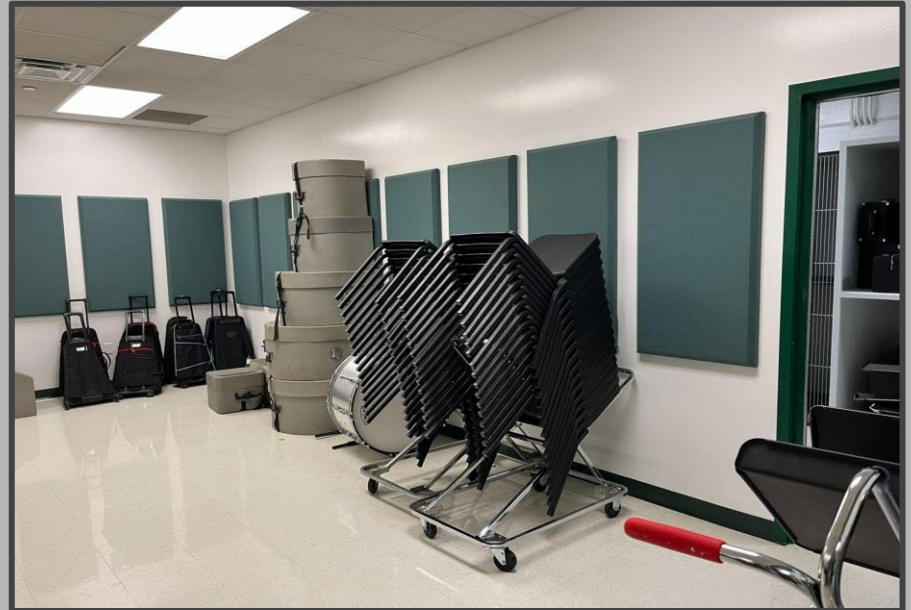
# Band Storage

The locker areas and storage for band are “hidden” and is not conducive to proper supervision of students and instruments. The area is not equipped to handle the amount of instruments and equipment for band.

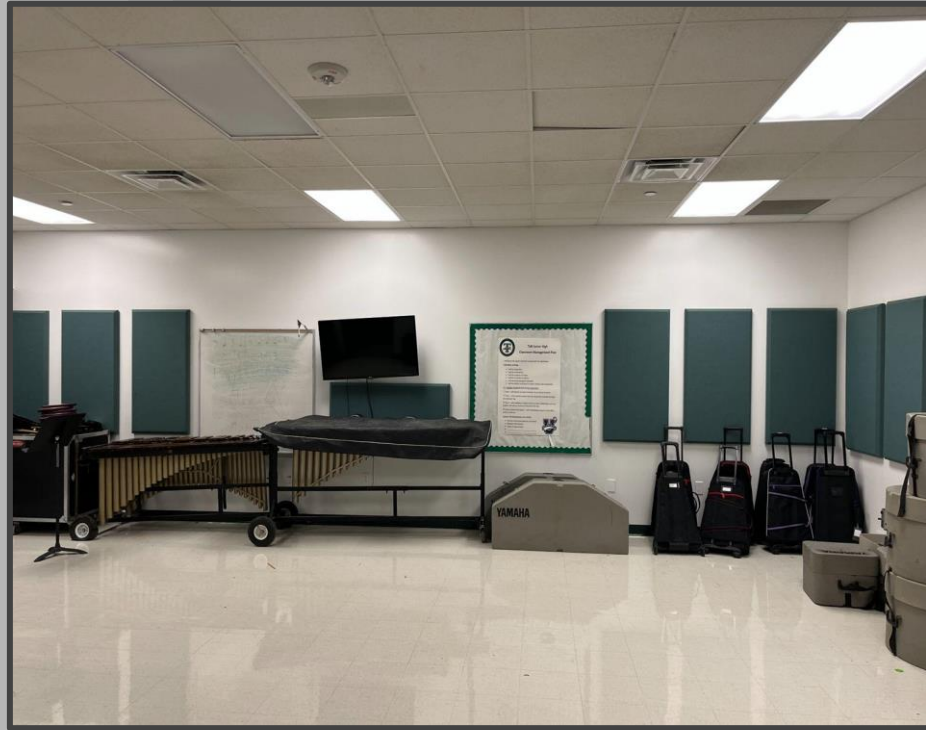
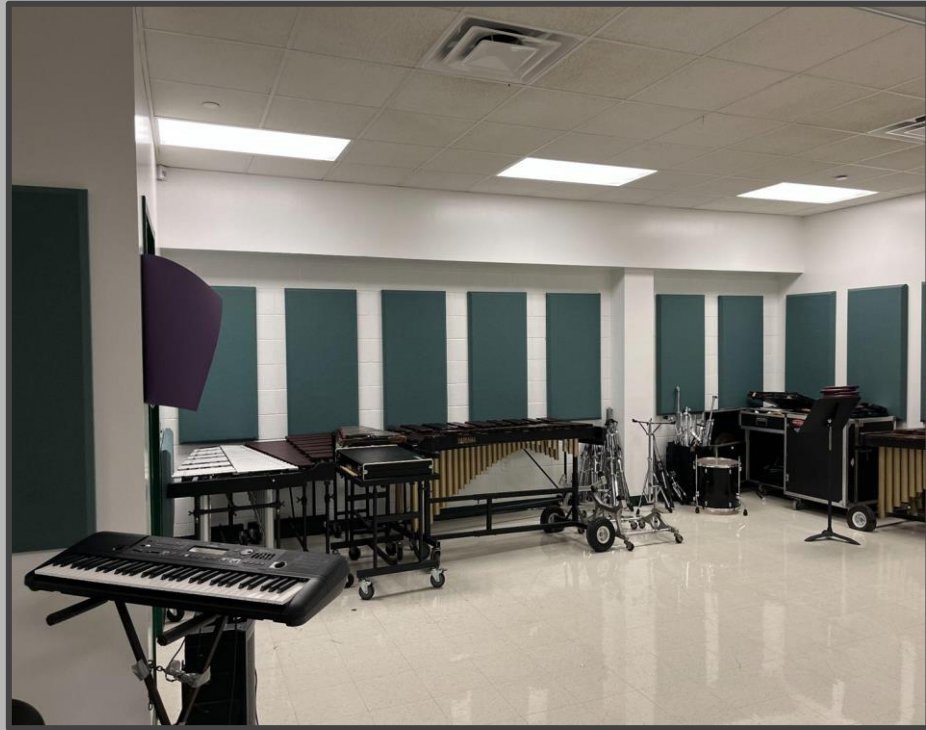
# Band Hall Practice Area

This area is typically where percussion practices. The area faces low ceiling, acoustic obstacles (sound) as well as small storage area/conductor area.

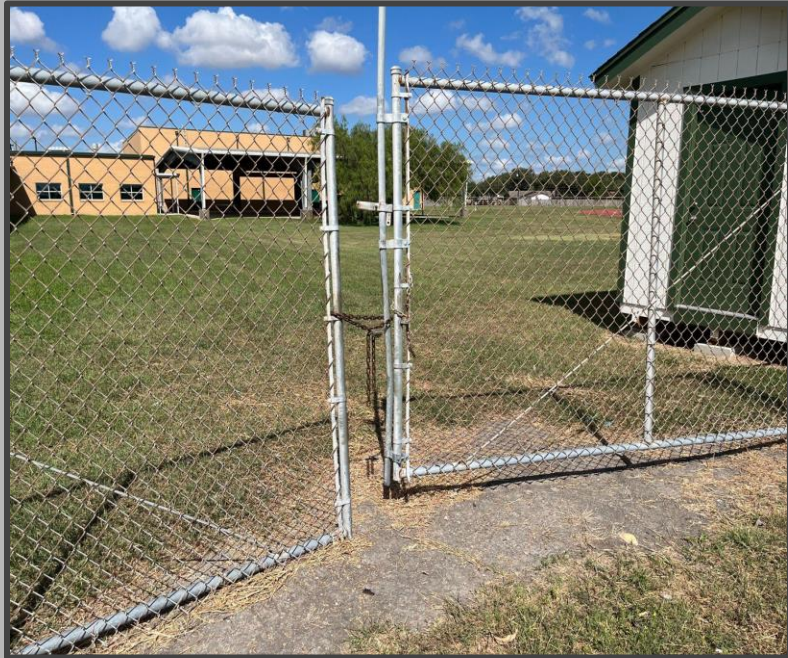
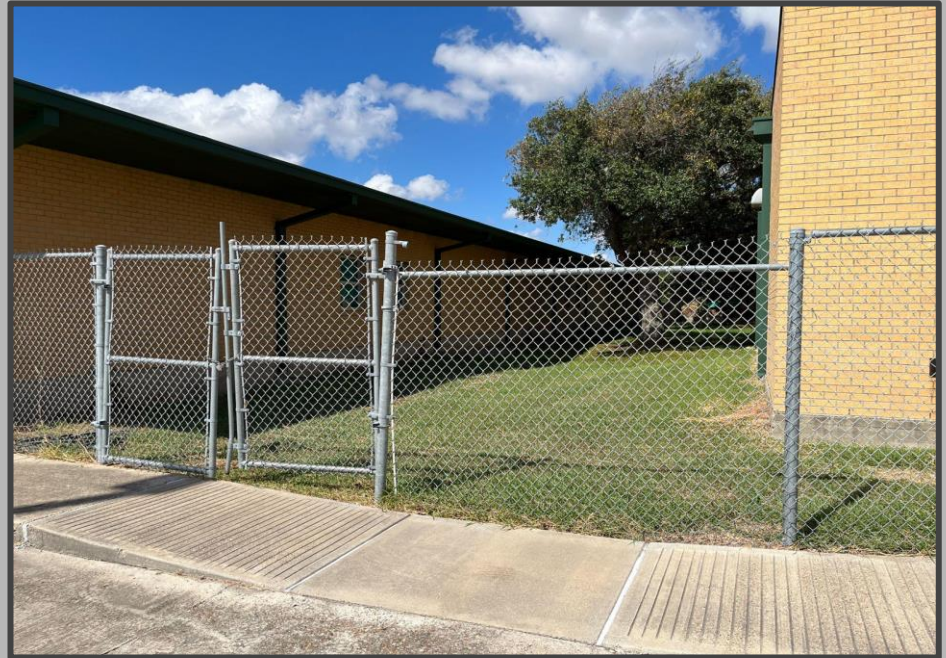
Fencing around the perimeter of the campus along with upgrading camera system is also a priority. Lighting around the exterior of the campus is currently being addressed with LED lighting. Communication System is not effective to reach the outside of the building and in the gym, there is no PA system.

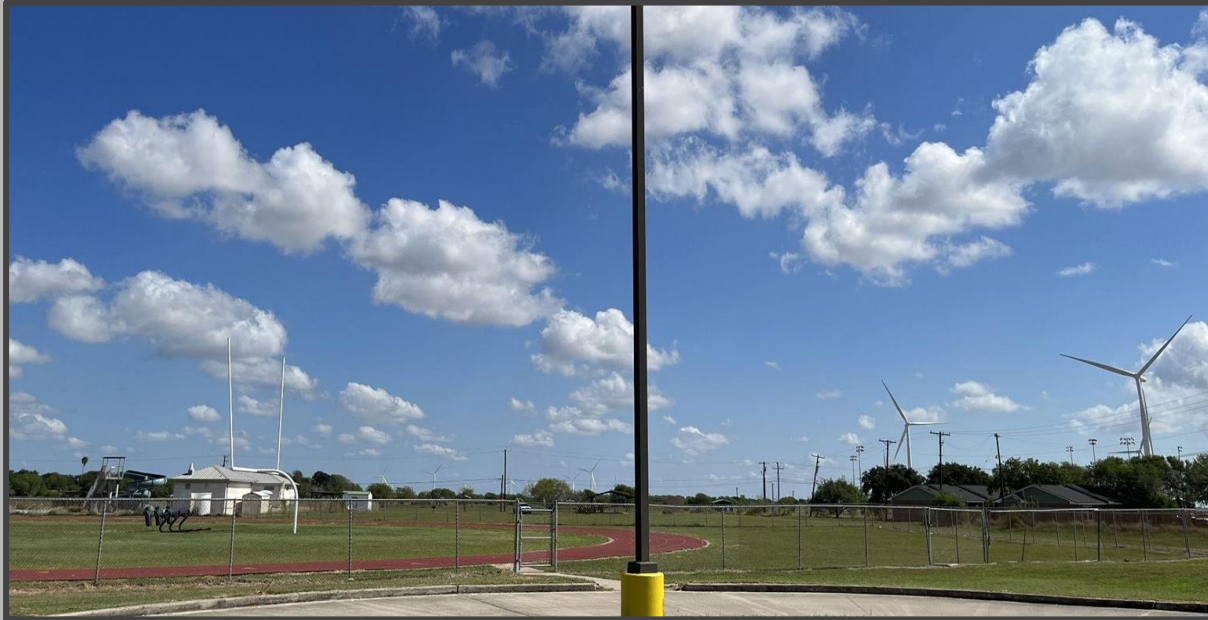
Track fence/gate. The gate to the track does have a gap with a combination lock key. The fence to the right of it has fallen and does not provide a stable structure.
